ARMY ENGINEER WATERWAYS EXPERIMENT STATION VICKSBURG--ETC F/6 20/4
SPILLWAY FOR COOPER DAM, SULPHUR RIVER, TEXAS. HYDRAULIC MODEL --ETC(U)
AUG 80 J F GEORGE
WES/TR/HL-80-15

1. REPORT NUMBER Technical Report HL-86-15 ✓	2. GOVT ACCESSION NO. AD-A094 237	3. RECIPIENT'S CATALOG NUMBER
4. TITLE (and Subtitle) SPILLWAY FOR COOPER DAM, SULPHUR RIVER, TEXAS Hydraulic Model Investigation,		5. TYPE OF REPORT & PERIOD COVERED Final report.

SPILLWAY FOR COOPER DAM, SULPHUR RIVER, TEXAS

Hydraulic Model Investigation

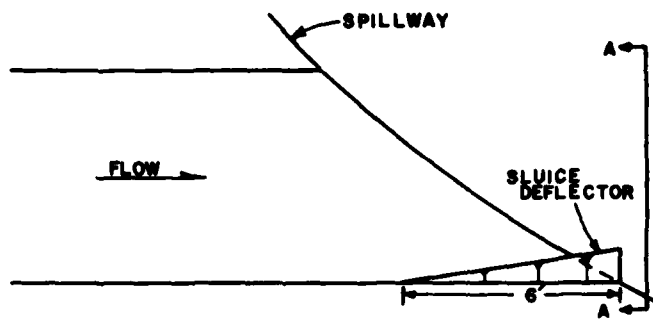
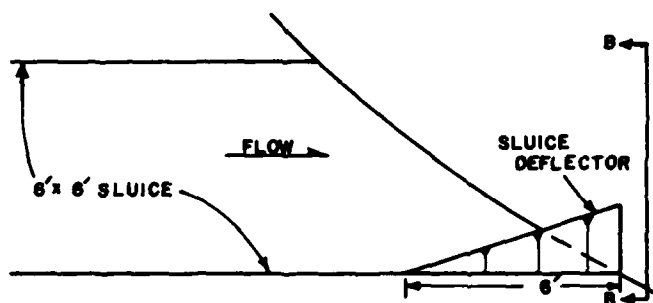
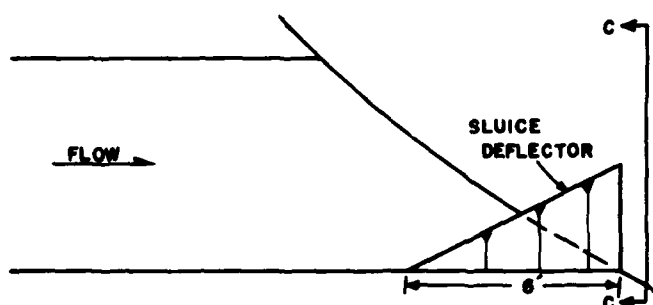
PLATE 14

CHUTE BLOCKS
TYPES A, B, AND C

SLUICE DEFLECTORS
TYPES 1, 2, AND 3

21. Tests were conducted to evaluate the effectiveness of placing chute blocks on the spillway trajectory to spread and distribute the flow entering the stilling basin. Several types of chute blocks (Plate 14) were tested in an effort to improve flow distribution across the lower parabolic trajectory of the spillway with gated discharges of 10,000 cfs and less. Little improvement in flow distribution and stilling basin performance was observed with these modifications and normal tailwaters. Since modifications on the trajectory were ineffective in

26. Various size chute blocks (Plate 14) were placed immediately downstream of the sluice outlets to aid in spreading the flow entering the stilling basin. The chute blocks were found to be ineffective in spreading releases from the sluices across the trajectory with normal tailwater depths.
